Manhole Inspection Summary

Manhole # S31EE2003MH

Insp Date: **12/6/06 9:51 AM**

Location Address: **5613 ENDERLY RD**

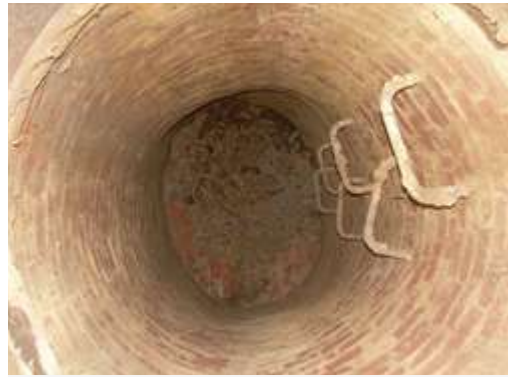
Top View

Corroded steps. Channel debris.

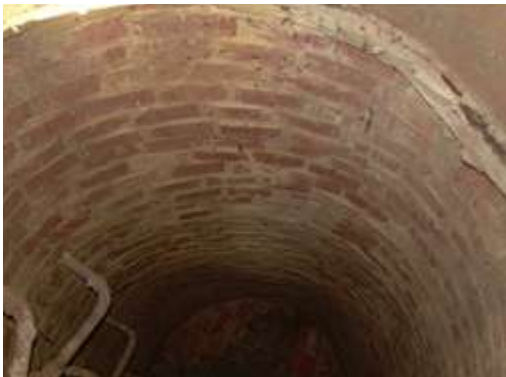
Defect

Adjustment, Corbel, and Barrel infiltration.

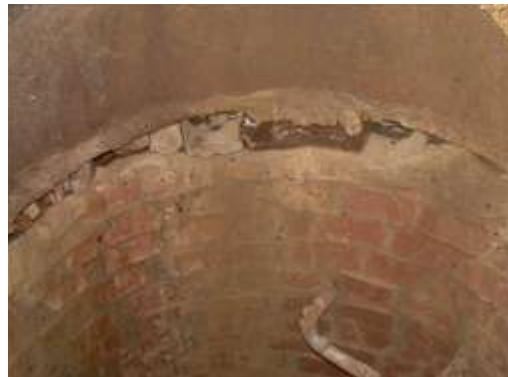
Defect

Frame leaks. Adjustment deterioration, loose brick, and infiltration.

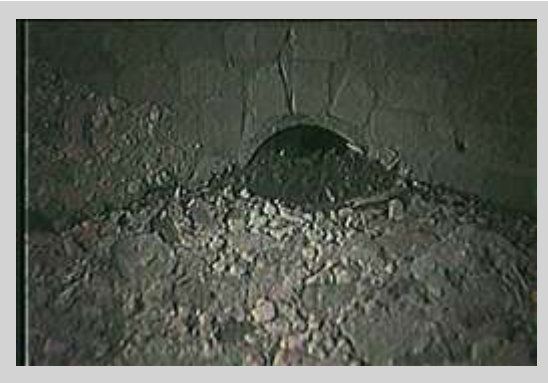
8 in. Circular Gravity Sewer
Pipe Out @ 12 O'Clock

Barrel crack.

Deposits: ☐ None ☒ **Mud** ☐ Sludge ☒ **Debris** ☐ Grease

Silt Depth: **5** (in.) Deposits Extent: **Heavy**

Infiltration: **Evidence** Pipe Seal Cond: **Unknown**
